FATIGUE RESPONSE OF THIN STIFFENED ALUMINUM CRACKED PANELS REPAIRED WITH BONDED COMPOSITE PATCHES

THESIS

AFIT/GMS/ENY/01M-01

AIR FORCE INSTITUTE OF TECHNOLOGY

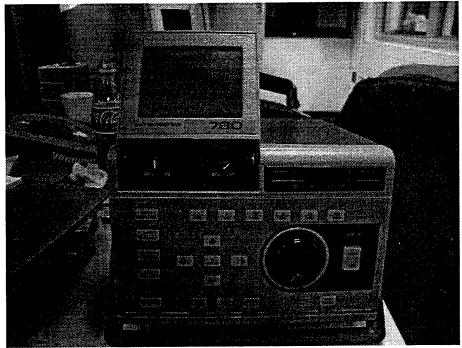
Figure 30 Inframetrics 760 IR Data Acquisition Device
